City of Somerville — RFP nº 12-71

ADA Self-Evaluation (as basis for Transition Plan)

Prepared by
Institute for Human Centered Design
August 12, 2013

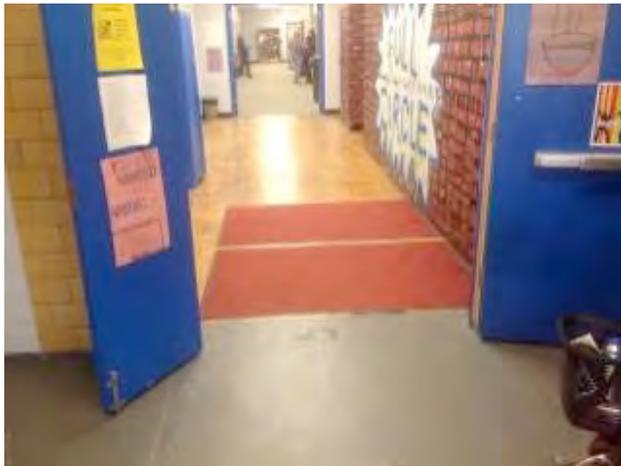
Photo 8

At circulation areas as well as certain offices, several weather mats are not secure and can become tripping hazards to faculty and students. (Photo 8)

1. Secure all weather mats with industrial-strength double-stick tape. Alternatively, replace them with recessed walk-off mats or grates.

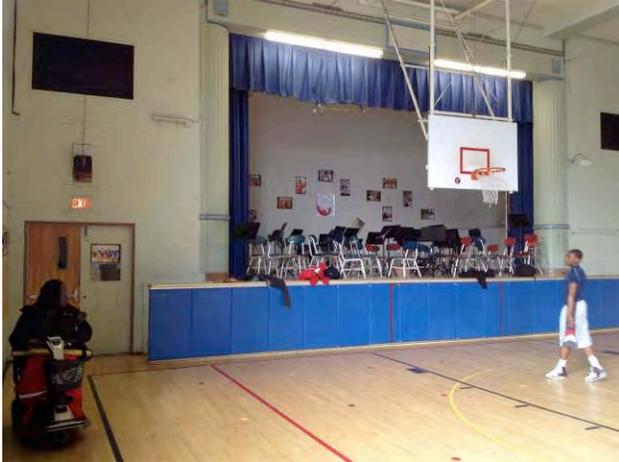
Photo 10

On the second floor, a stage is found inside the gym. No accessible route is provided between the gym level and the stage. (Photo 10)

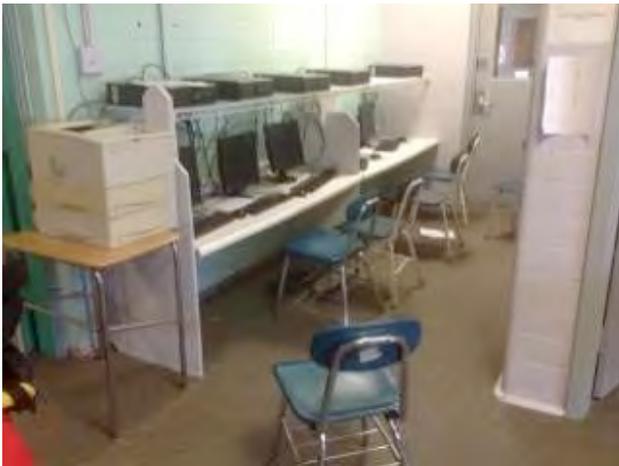
Photo 11

- each type of science lab lacked a permanent or moveable accessible student lab station;
- specialized work stations, including computer stations, may require extended forward reach ranges and or lack knee/toe clearance. (Photo 11)
- safety equipment such as blankets, showers, and eye wash stations were blocked by furniture, located outside of reach range, or were otherwise inaccessible.

Specific workstations such as those with computers do not provide the required knee and toe clearance. (Photo 11)

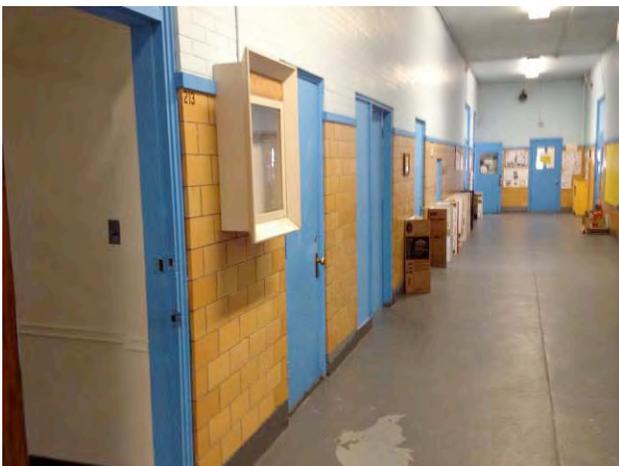
Photo 12

Very little signage is provided at this facility and not all permanent rooms and spaces are properly identified with ADA-compliant signs. (Photo 12)

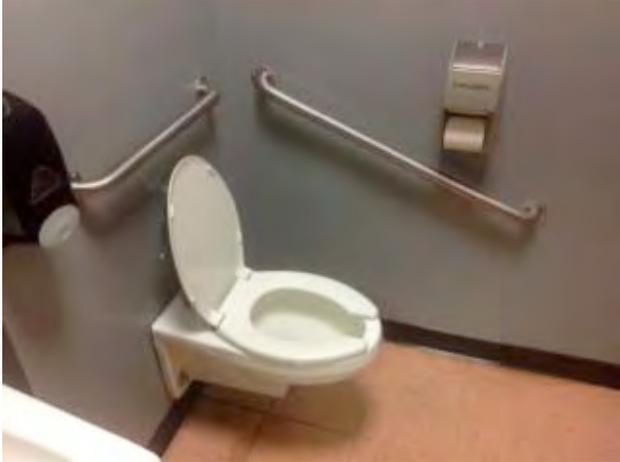
Photo 13

A unisex, single-user toilet room for staff and student use is located on the second floor. Although this toilet room is generally usable by persons with disabilities, it does not meet all of the requirements of applicable accessibility standards because the mirror above the lavatory exceeds the maximum allowable height and the side grab bar is mounted incorrect. (Photo 13)

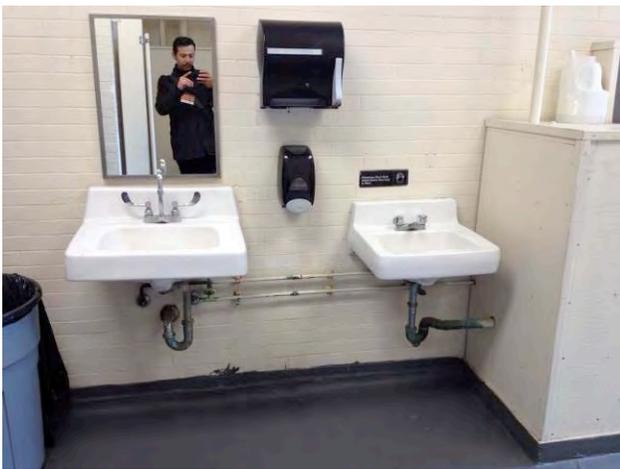
Photo 14

Multi-user toilet rooms for staff and student use are found on all floor levels. Neither toilet rooms are accessible because plumbing underneath lavatories is unprotected, accessible toilet stalls are not provided, nor do accessories or fixtures meet height requirements for children. (Photo 14)

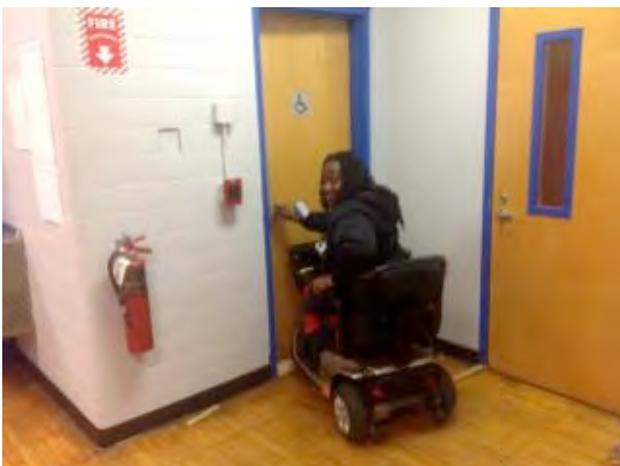
Photo 15

Although a sign has been installed on the door to the single-user toilet room on the second floor, none of the toilet rooms in the building have accessible signage. (Photo 15)

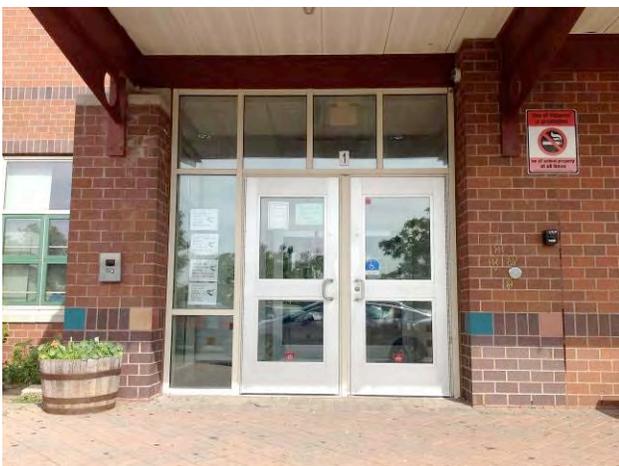
Photo 3

The building has one public entrance on Meacham Street as well as locked employee only entrances. Each of the entrances occur at grade and have double doors. The main entrance is visible from the office, however, the intercom lacks accessible signage and its clear space is blocked by a flower planter. (Photo 3)

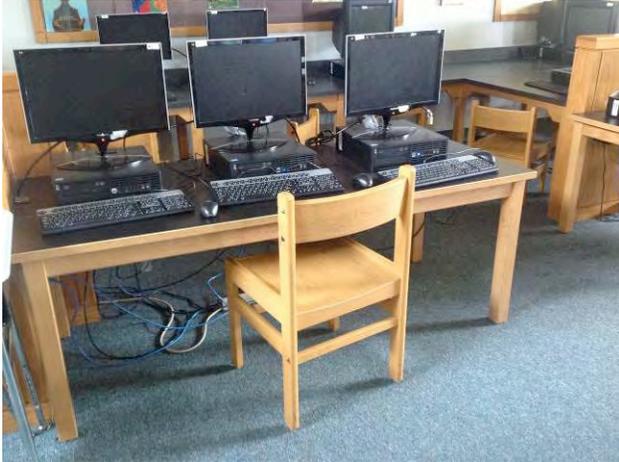
Photo 4

- computer and library media lab work surfaces provided less than 27 inches of knee clearance, no accessible stations were found; (Photo 4)
- each type of science lab lacked a permanent or moveable accessible student lab station; (Photo 5)
- emergency equipment such as eyewash stations may require extended forward reach ranges and or lack knee/toe clearance. (Photo 6)

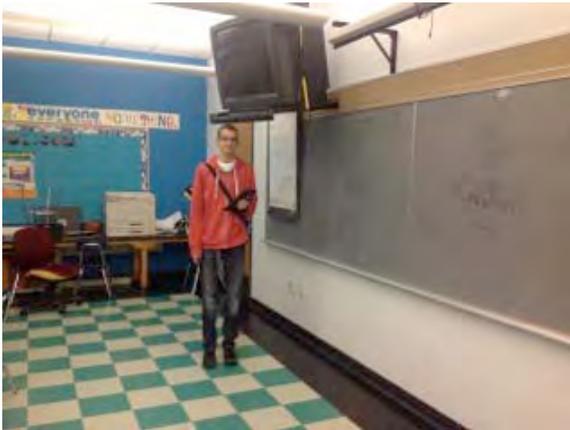
Photo 8

- hanging TVs and network/data boxes; (Photo 8)
- display cases;
- automatic external defibrillator
- fire extinguishers;
- underside of egress stairways. (Photo 9)

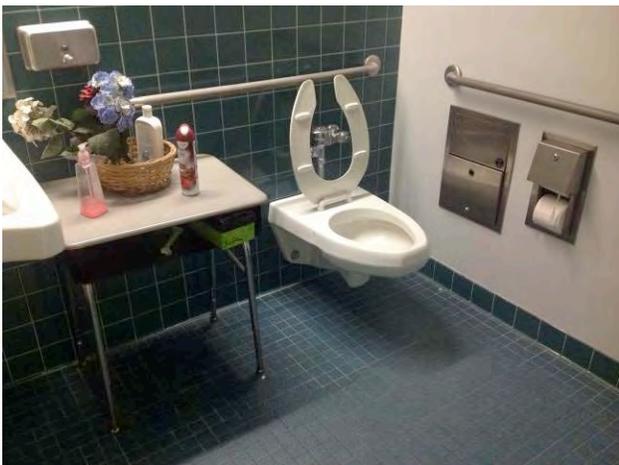
Photo 11

- Access between classrooms or in toilet rooms is sometimes obstructed by furniture. (Photo 10 and 11)

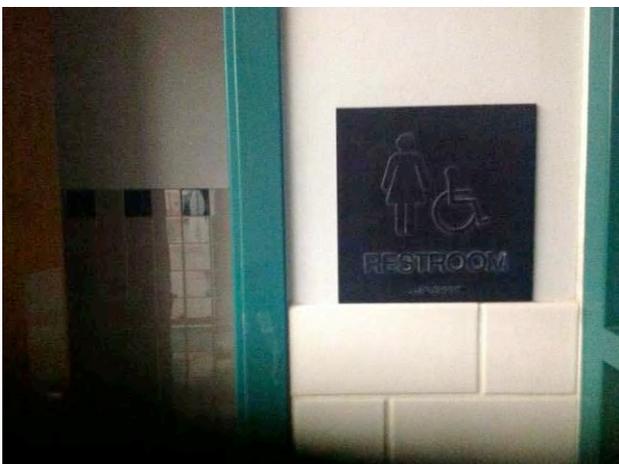
Photo 12

- Braille was typically missing from signage
- Classroom designation signage is covered by artwork;
- Accessible entrances have worn or are missing ISA symbol. (Photo 12)

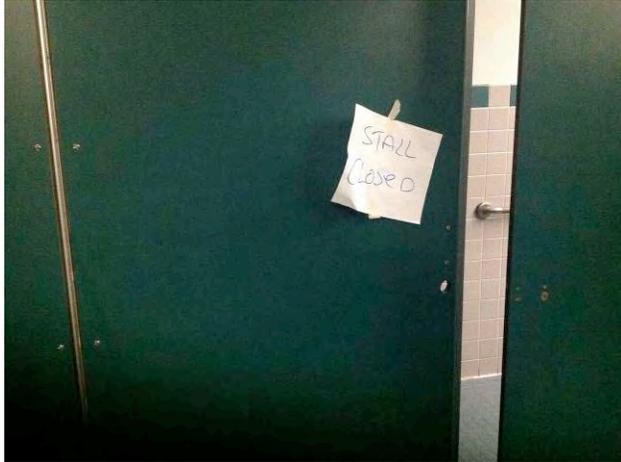
Photo 13

- Accessible features including dispensers, accessible stall locks and toilets were broken or missing in multi-user toilet rooms. Accessible signage identifying the toilet rooms as inaccessible and directions to accessible toilet rooms was not provided; (Photo 13)
- Urinals and urinal privacy screens reduced the accessible route clear width to less than 32 inches (for example see toilet room near classroom #211); (Photo 14)
- Urinals visible from hall lacked privacy screens (for example see toilet room near music room #310); (Photo 15)

1. Maintain accessible features including dispensers, accessible stall locks and toilets.
2. If accessible toilets are not repaired, provide signage that directs to functioning accessible toilets.
3. Make minor modifications to adult toilet rooms.
4. Develop policies and procedures to ensure toilet rooms are not used for storage.
5. Ensure that there are an adequate number of toilet rooms for each age group served. Note that there are specific ADA and MAAB toilet and sink requirements for K-3, and 4-6.

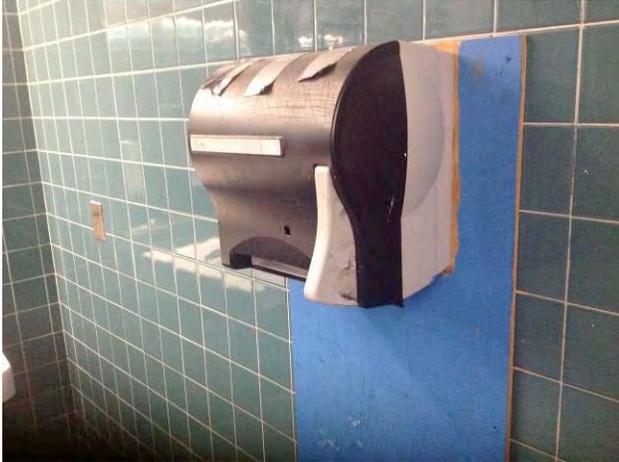
Photo 16

- Replacement dispensers are protruding objects; (Photo 16)
- Lavatories had exposed pipes.

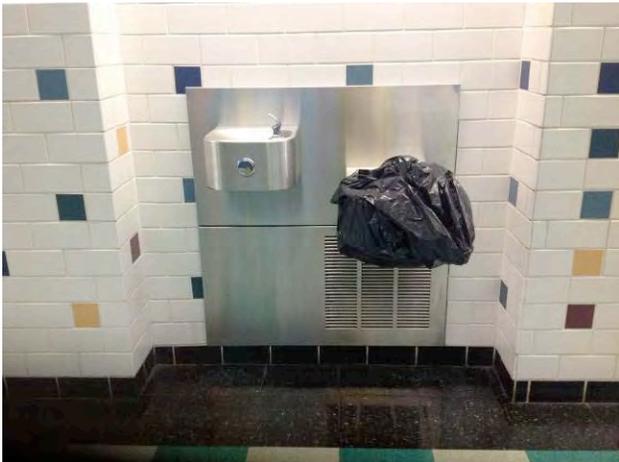
Photo 17

Hi-lo drinking fountains are not maintained. Older inset wall models are too high to be accessible and signage is not provided to direct users to the functioning accessible drinking fountains. (Photo 17 and 18)

1. Repair accessible drinking fountains.
2. Provide signage at inaccessible drinking fountains that directs to accessible models.

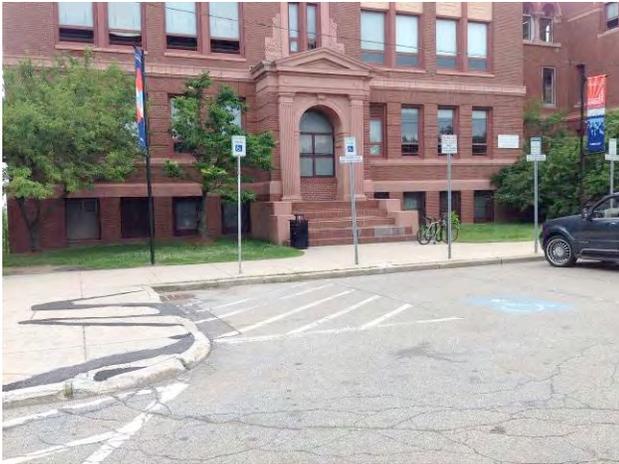
Photo 1

- Inadequate number of accessible spaces (6-7 required) including van accessible van parking spaces;
- one accessible parking space with 96-inch wide access aisle adjacent to city hall – markings are not highly visible, van designated sign is missing, curb ramp issues; (Photo 1)

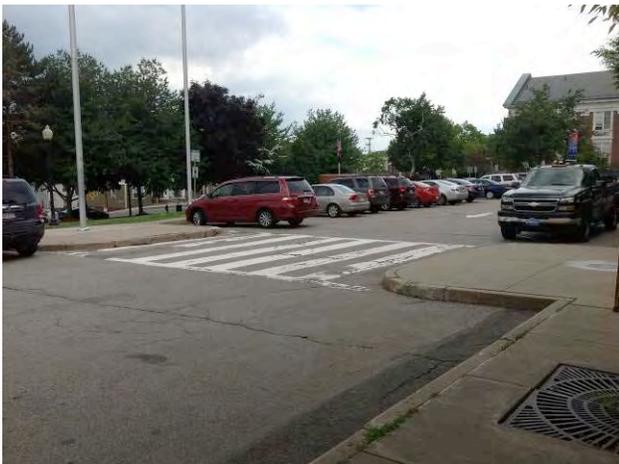
Photo 2

- one accessible parking space directly across from main entrance used by staff – access aisle is missing; (Photo 2)
- three accessible parking spaces near the accessible entrance – two spaces facing building C exceed running slope slightly, one space facing building D has excessive slopes; All spaces: markings are not highly visible, sign for one accessible parking space is missing, van designated sign is missing and have curb ramp issues; (Photo 3)

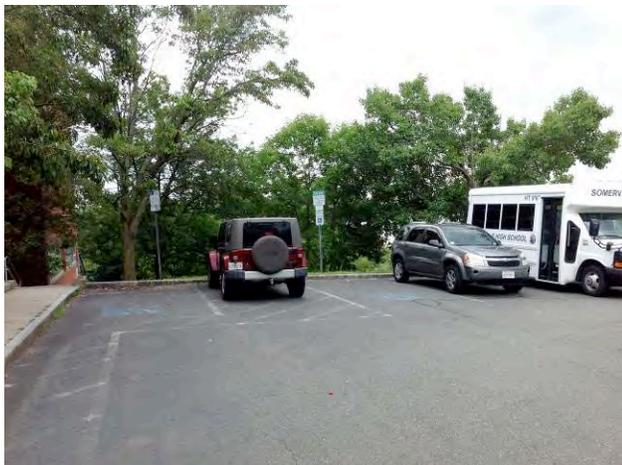
Photo 4

- two accessible parking spaces with 96-inch wide access aisle – have slightly excessive slopes, markings are not highly visible, van designated sign is missing; (Photo 4)

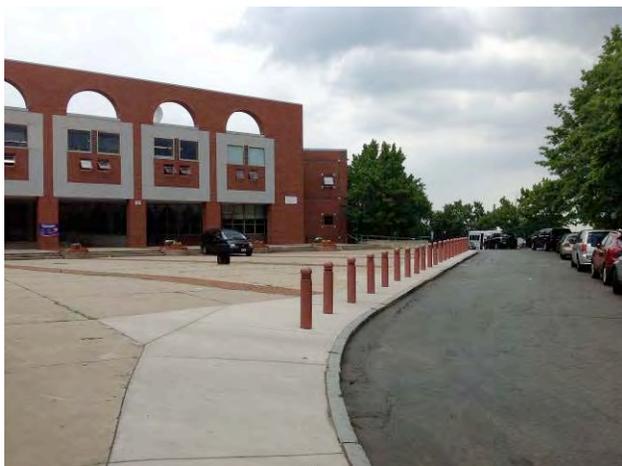
Photo 5

The sloped walkway leading to the DayCare and rear Health Center entrance exceeds 5%, lacks level landings where walkways and doors intersect and railings. The rear health center landing does not provide the required clear space at latch pull side and card reader.

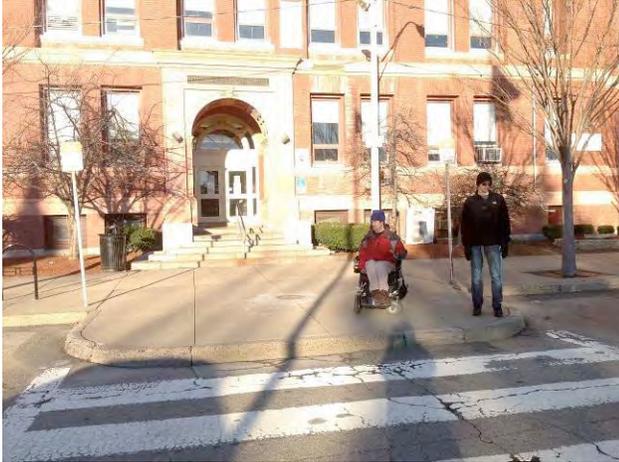
Photo 7

Although the sidewalks are in reasonable condition, portions of the sidewalks have vertical displacements greater than 1/2 inch, cross slopes in excess of 1:48 and no curb ramps are provided to reach flag poles.

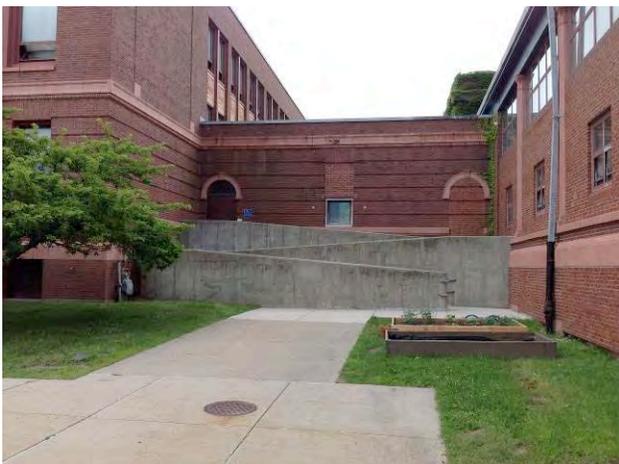
Photo 9

- finally though not a code issue, the high ramp walls block visual sight lines to the ramp from the street, parking and entrance; As a consequence, entrance users cannot be seen or look out to the parking lot. (Photo 9)

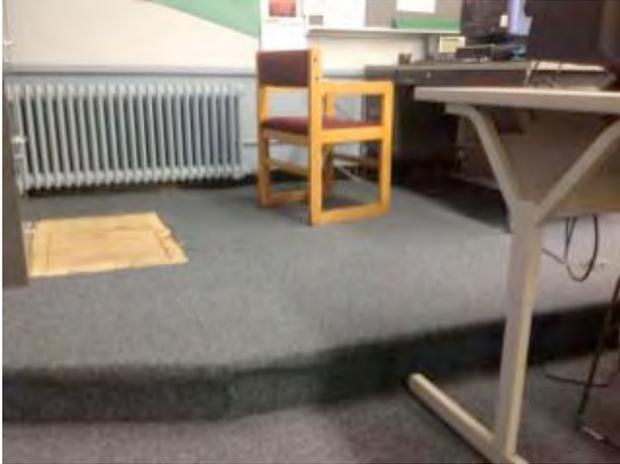
Photo 13

- raised podiums such as in language labs lacked accessible routes; (Photo 13)
- each type of science lab lacked a permanent or moveable accessible student lab station; (Photo 14)
- risers in music rooms;
- teacher demonstration stations at front of labs lacked 5-foot turning radius between station and whiteboard as well as an accessible counter and sink;
- specialized work stations or shop equipment may require extended forward reach ranges and or lack knee/toe clearance.
- safety equipment such as blankets, showers, and eye wash stations were blocked by furniture, located outside of reach range, or were otherwise inaccessible;
- the exterior entrance vestibule to the health center lacks sufficient clear space at door.

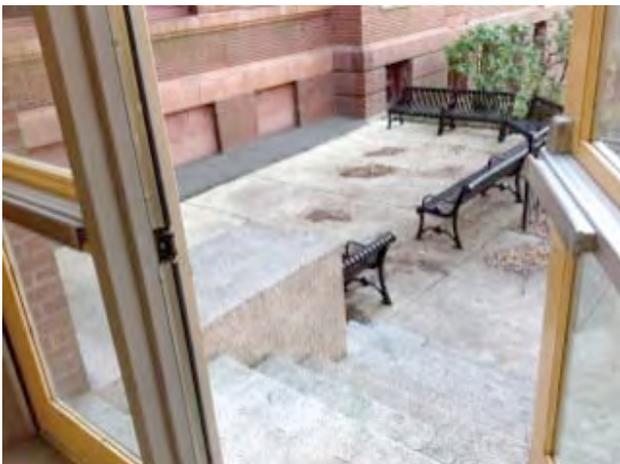
Photo 15

- the outdoor classroom space is reachable only via stairs from its entry door; (Photo 15)
- the TV studio under the library has a stair only exterior entrance as well as a raised broadcast area. It can be accessed by first entering the daycare area, but it is unclear whether this route works when the daycare is closed. Likewise, there is no accessible route to the raised broadcast area. (Photo 16)

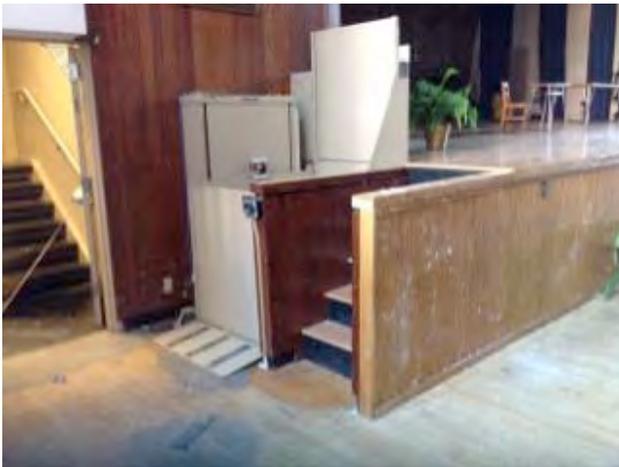
Photo 17

Two lifts were identified in the High School: Auditorium and Library. The lifts were not independently operable and did not meet current lift requirements including weight capacity and were unable to lift less than the stated weight capacity. Additionally, the lift providing access to the stage is situated in such a manner that a person requiring the lift could not access back stage areas without interrupting performances on the stage. (Photo 17)

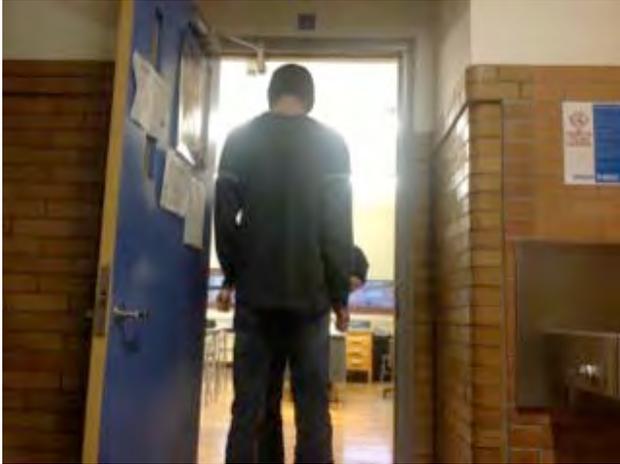
Photo 19

- most restrooms in buildings A, B, C, & D have doors in a series where the outer door was removed long ago but the door frame was not. This results in constricted and inadequate maneuvering clearance on the latch pull side; (Photo 18)
- many doors lack maneuvering clearance on the latch pull side; (Photo 19)
- certain spaces have doors that do not provide the minimum 32-inch clear width for accessible doors;
- dozens of single- and double-leaf doors exceed the maximum allowable force required to open them. The worst seem to be the Main and Guidance offices as well as various doors into labs and shops;
- some doors have non-compliant hardware;
- the exterior entrance vestibule to the health center lacks sufficient clear space at door.

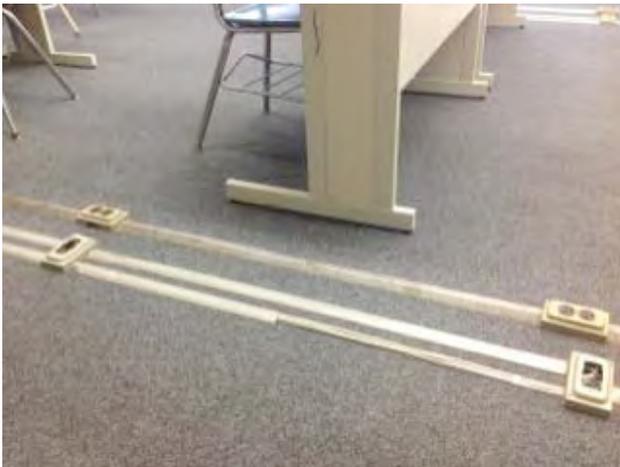
Photo 20

- thresholds greater than 1/2 inch and often greater than one inch at many classroom doors;
- conduit, junction boxes/outlets and loose wiring on floors create tripping hazards; (Photo 20)
- in the basement hallways of these same buildings there are metal floor plates covering utilities and pipe runs. These plates may or may not be flush. In certain areas the plates or their frames are vertically displaced more than one inch; (Photo 21)
- these same buildings have large metal plates in many of the accessible toilet stalls. These plates are often angled toward the adjacent sidewall and radiator thus making the floors in front of and alongside the toilet uneven.

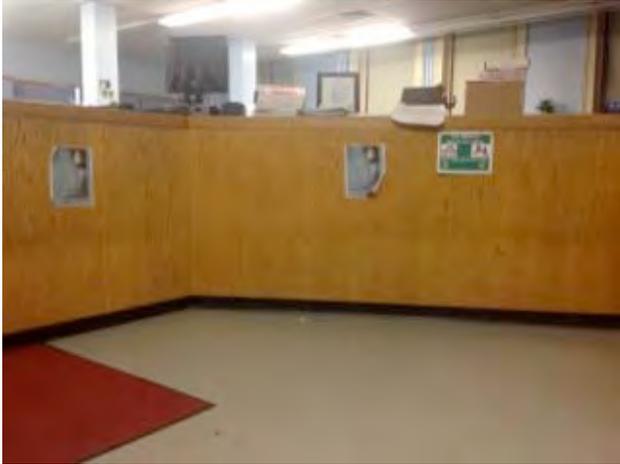
Photo 22

At the Main Office, Auto Repair, Cosmetology, and other areas, the service counters exceed the maximum allowable height for visitors using wheeled mobility devices or who are of short stature. (Photo 22)

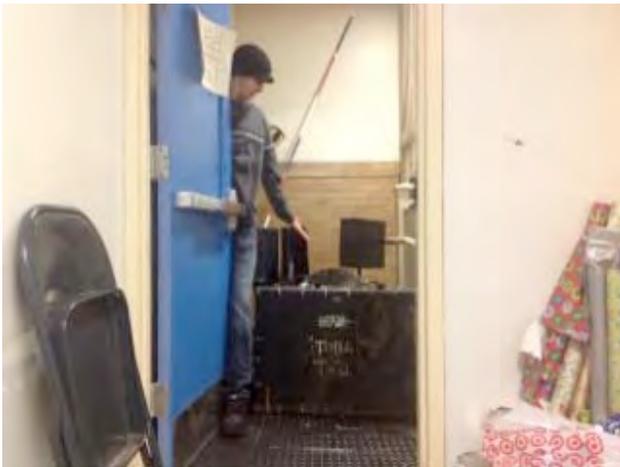
Photo 23

Multiple egress stairways offer vertical circulation to all floor levels. However no stairwell is designated as an Area of Refuge nor equipped with an evacuation chair. Some egress stairways such as those adjacent to the music department and in the front of the library have become de facto storage closets with landings and treads occupied by objects. (Photo 23)

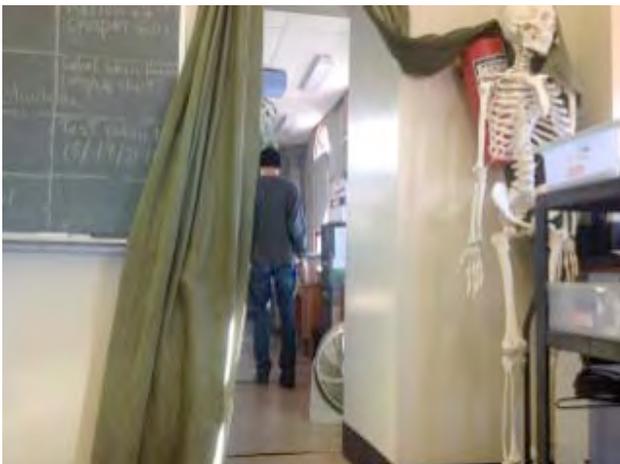
Photo 24

- Changes in level greater than 1:20 are present in the hallways leading to the cafeteria and in the music department area;
- Access between classrooms, lab prep rooms and shops is often obstructed by furniture or less than 32-inch clear width. (Photo 24)

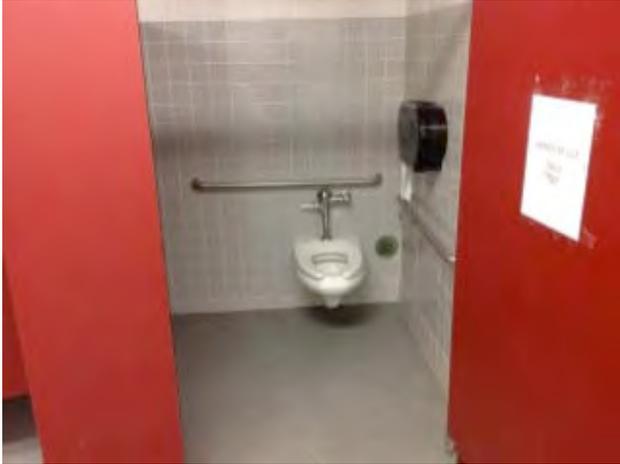
Photo 25

Student use toilet rooms adjacent to the cafeteria have the following issues: (Photo 25)

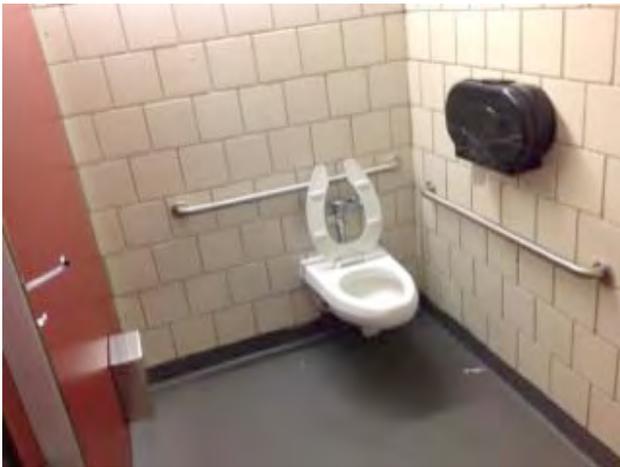
Photo 26

- Semi-recessed metal floor plates were found within many of the accessible toilet stalls. These plates are often angled toward the adjacent sidewall and radiator thus making the floor alongside the toilet uneven;
- One or more grab bars is incorrectly mounted or does not meet dimensional requirements; (Photo 26)
- Stall dispensers are mounted incorrectly;
- Latches are broken or require tight pinching, grasping or twisting;
- Coat hooks are missing or are mounted incorrectly;
- Lavatories lack sufficient knee clearance, wrapped pipes, and/or accessible faucets; (Photo 27)
- Soap and paper towel dispensers are mounted incorrectly or lack clear space in front of them; (Photo 27)
- Mirrors are missing or are mounted incorrectly.

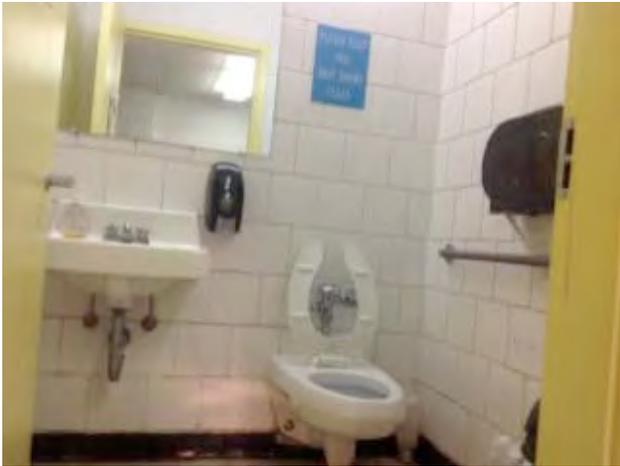
Photo 28

Toilet rooms located in career oriented shops within building F are completely inaccessible. (Photo 28)

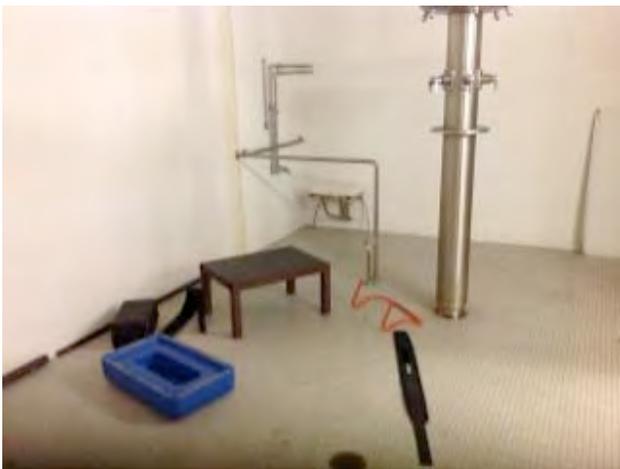
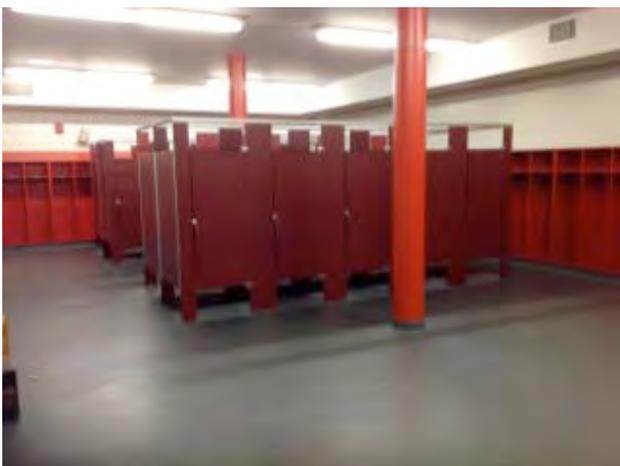
Locker rooms are provided in several shops in addition to the gym. The locker rooms located in career oriented shops within building F are completely inaccessible. The gymnasium locker rooms have the following issues: (Photos 29 and 30)

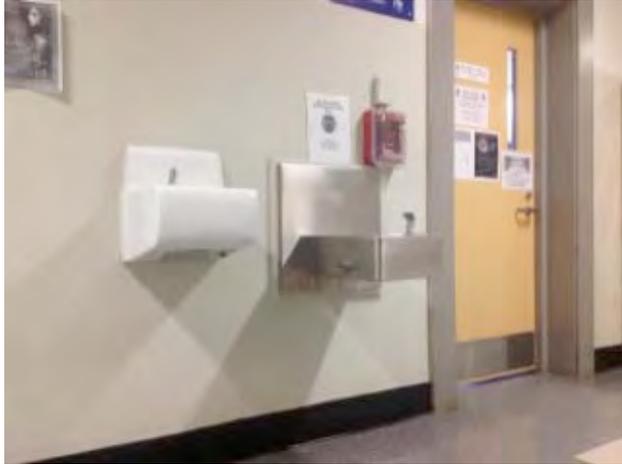
Photo 31

Drinking fountains are provided in most buildings and on most floors. Most were inaccessible because they lacked sufficient clearance and/or had inaccessible controls that required twisting. Others such as the one pictured are accessible but the controls are inaccessible. (Photo 31)

1. Budget for the replacement of all drinking fountains with high efficiency accessible hi-lo models.

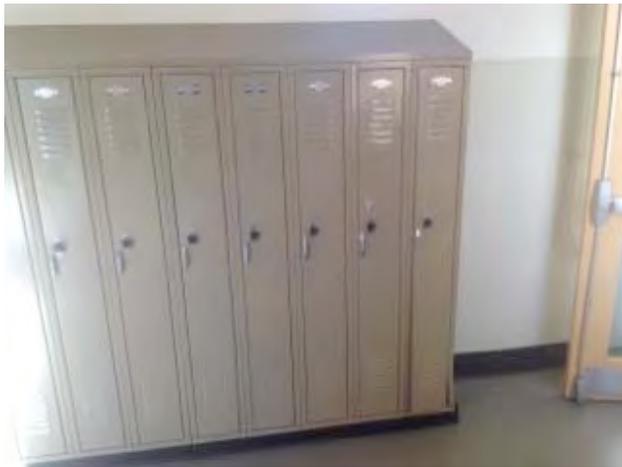
Photo 32

There are thousands of lockers in the high school but school staff indicated none were accessible. (Photo 32)

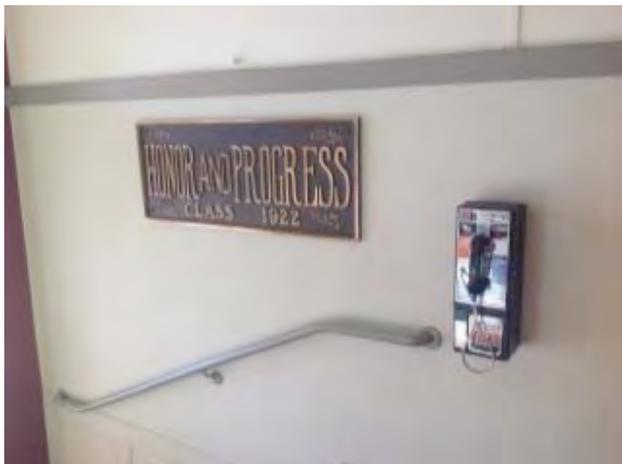
Photo 33

Both public pay phones lack signage indicating availability of TDD/TTY, nor was a TDD/TTY found. (Photo 33)

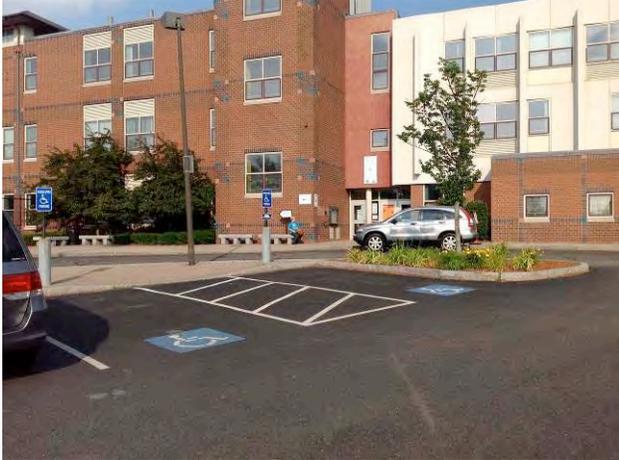
Photo 1

- Running and cross slopes slightly exceed 1:48 in any direction; (Photo 1)
- A sign for van designated space is missing at the parking lot off Sartwell Avenue. (Photo 2)

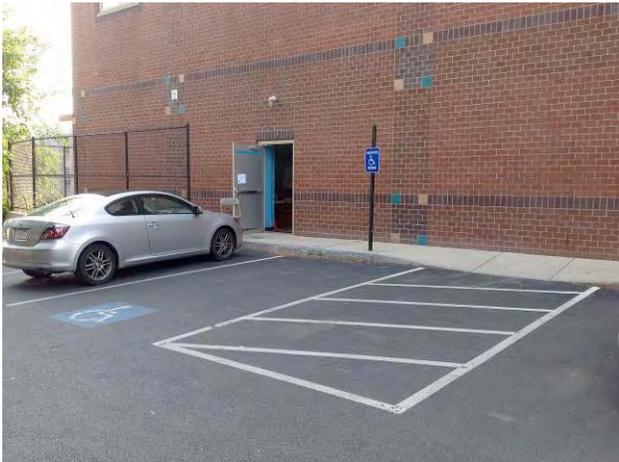
Photo 2

The Kennedy School has pedestrian and vehicular entrances along Elm, Cherry and Sartwell. At each driveway, curb ramps either exceed maximum running or cross slope requirements, have vertical lips greater than 1/2 inch or lack level landings. (Photos 2 and 3)

1. Remove lips on curb ramps;
2. Reconstruct curb ramps with excessive slopes or lacking level landings.
3. Install missing curb ramp along Sartwell Avenue.

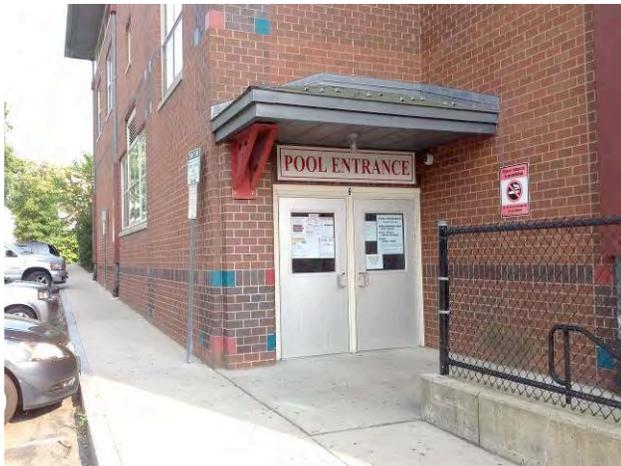
Photo 4

The pool entrance is inaccessible from Sartwell Avenue because it can only be accessed by a stairway. (Photo 4)

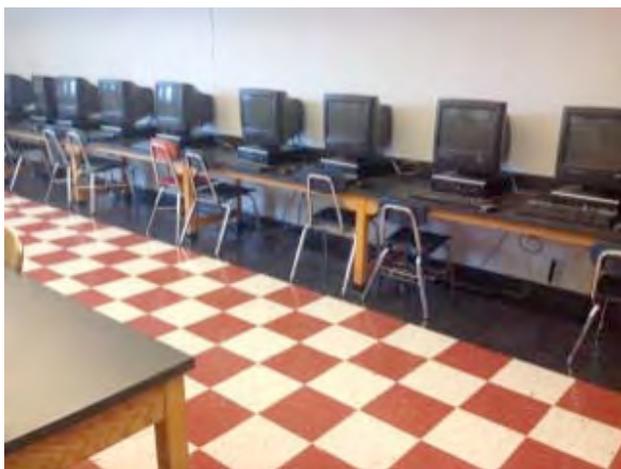
Photo 5

- Room #300, computer, and library media lab work surfaces provided less than 27 inches of knee clearance, no accessible stations were found; (Photo 5)
- Each type of science lab lacked a permanent or moveable accessible student lab station. (Photo 6)

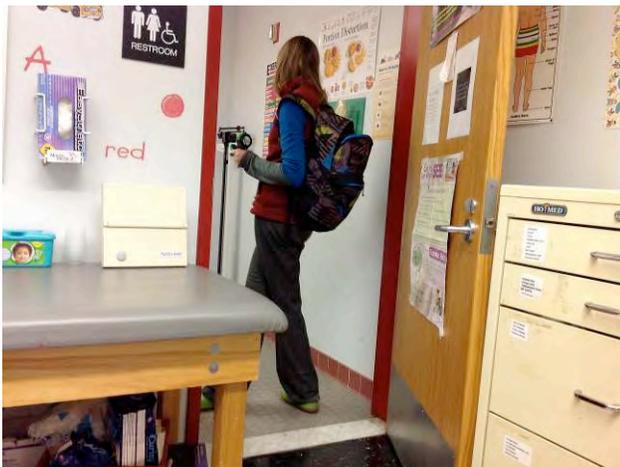
Photo 8

- Gates to athletic facilities lack smooth surfaces and accessible hardware;
- A few doors have reduced maneuvering clearance on the latch pull side or cannot open a full 90 degrees because of furniture or stored items; (Photo 8)
- Many single- and double-leaf doors exceed the maximum allowable force required to open them.

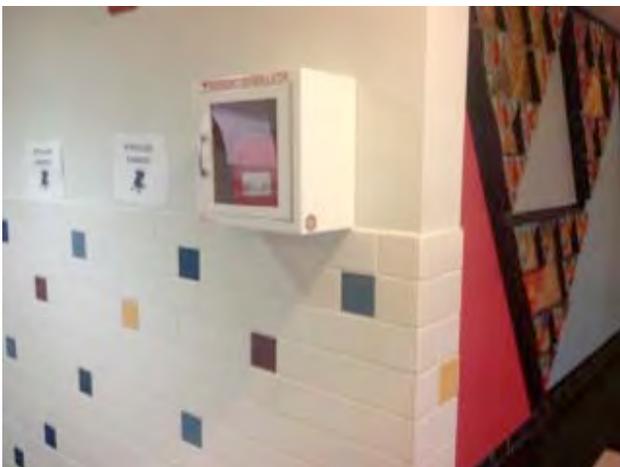
Photo 9

- Hanging TVs and network/data boxes;
- Automatic external defibrillators; (Photo 9)
- Fire extinguishers.

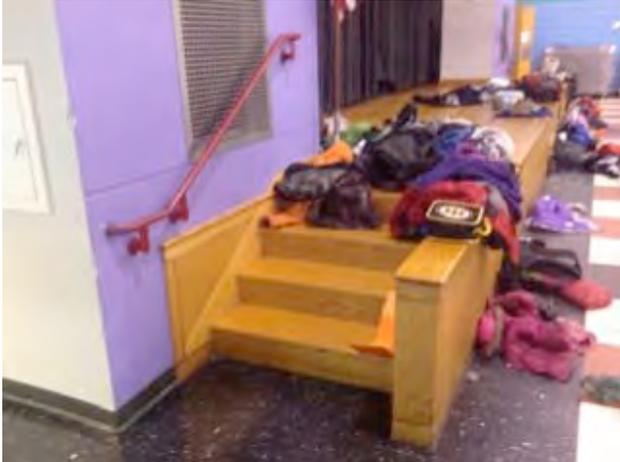
Photo 10

The 4-5 steps to the stage lack handrails on both sides. (Photo 10)

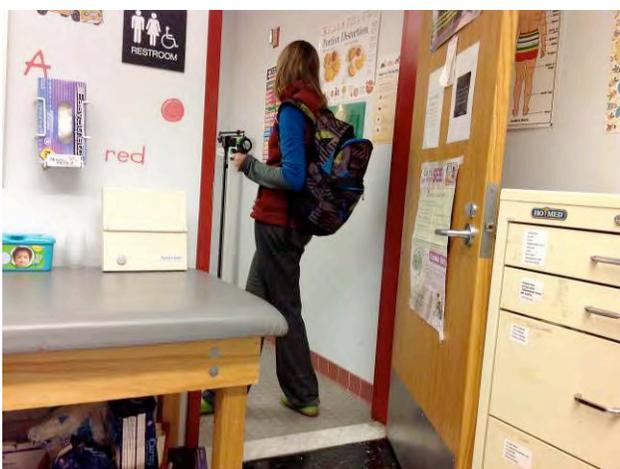
Photo 12

- There appears to be no accessible route to the stage in the cafeteria; (Photo 10)
- The interior ramp has a landing depth of less than 55 inches because of the wall mounted radiator; (Photo 11)
- Access between classrooms or offices is sometimes obstructed by furniture. (Photo 12)

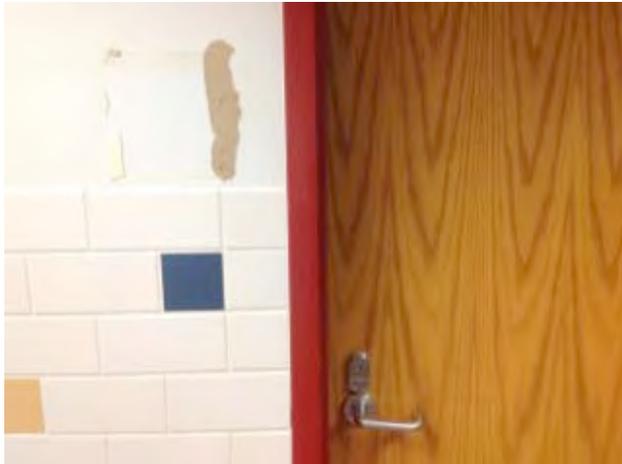
Photo 13

- Some permanent rooms were missing signage; (Photo 13)
- Classroom designation signage is covered by artwork;
- Accessible entrances have worn or are missing ISA symbol.

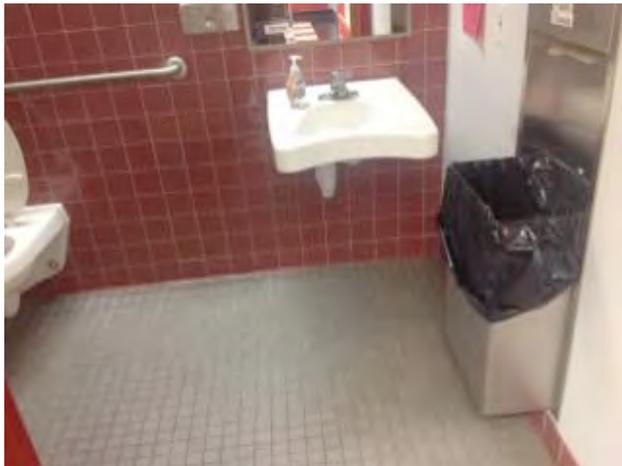
Photo 14

- A few toilets may be higher than 19 inches or lower than 17 inches above the floor;
- Some toilets may be further than 18 inches on center from the side wall;
- Height of toilet and grab bars may not match target age group the toilet room was designed for or used by;
- Accessible features including dispensers, accessible stall locks and toilets were broken or missing in multi-user toilet rooms. Until these hardware elements are replaced or fixed, provide accessible signage identifying the toilet rooms as inaccessible and directions to accessible toilet rooms;
- Trash receptacles may intrude on clear floor space of lavatories. (Photo 14)

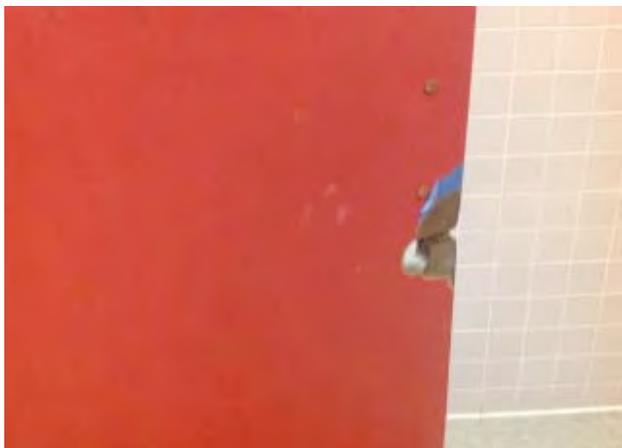
Photo 15

- Accessible features including dispensers, accessible stall locks and toilets were broken or missing in multi-user toilet rooms. Until these hardware elements are replaced or fixed, provide accessible signage identifying the toilet rooms as inaccessible and directions to accessible toilet rooms; (Photo 15 and 16)

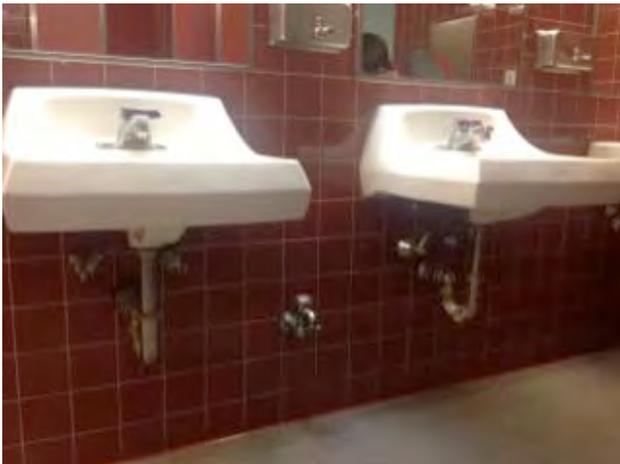
Photo 17

- Some accessible stalls have inaccessible sliding locks (example near room #327)
- A few toilets may be higher than 19 inches or lower than 17 inches above the floor;
- Some toilets may be further than 18 inches on center from side wall;
- Lavatories had exposed pipes; (Photo 17)
- While not required by ADA/AAB requirements: Urinal guards are missing (see male toilet room near room #320 for example). (Photo 18)

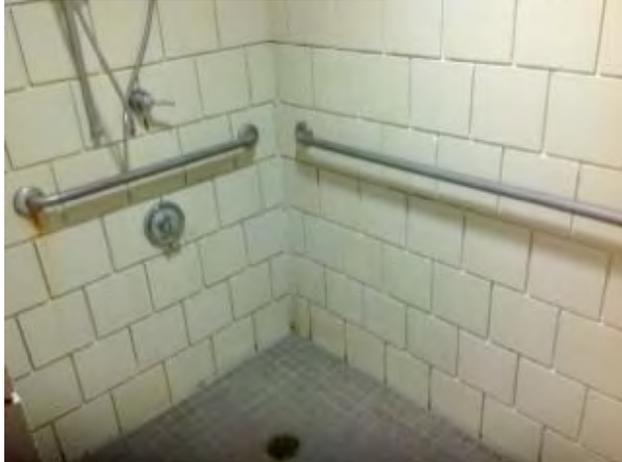
Photo 19

- Accessible shower stalls either are missing a wall mounted bench or have a bench that does not meet dimensional requirements for either MAAB or ADAAG; (Photo 19 and 20)
- Hand held spray hose is less than 60 inches long;
- No accessible lockers are provided;
- Fixed bench seats do not meet dimensional requirements;
- Baby changing stations, if provided, are not on accessible routes and lack clear floor space.

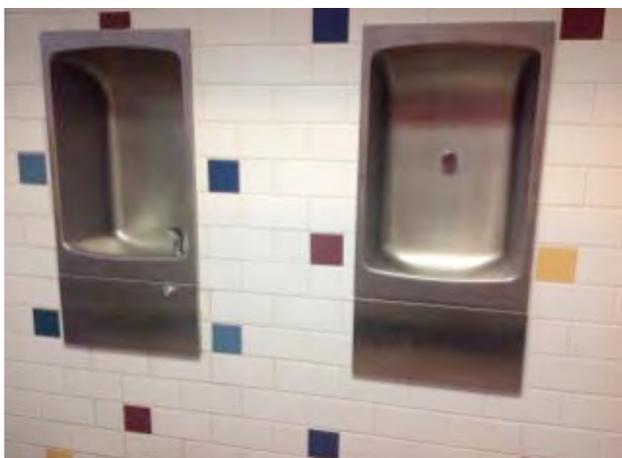
Photo 21

Hi-lo drinking fountains are not maintained. Older inset wall models are too high to be accessible and signage is not provided to direct users to the functioning accessible drinking fountains. (Photo 21)

1. Repair accessible drinking fountains;
2. Provide signage at inaccessible drinking fountains that directs to accessible models.

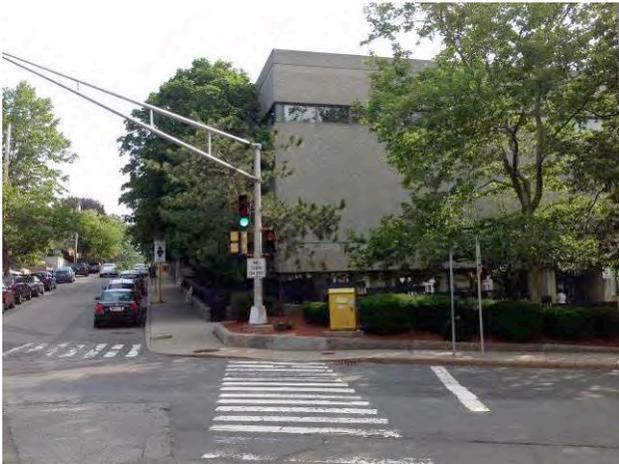
Photo 2

The entrances to the school are directly connected to the sidewalks along Medford, Sycamore, and Evergreen. The sidewalks and curb ramps are in poor condition. a deteriorated and excessively sloped section of the sidewalk can be found along the vehicular curb on Kidder Avenue. (Photos 2 and 3)

1. Either modify or renovate existing multi-user toilet rooms or construct one single-use accessible toilet room on each floor of building. Install signage to direct users to the accessible toilet room.
2. Replace curb ramps and sidewalk surfaces;

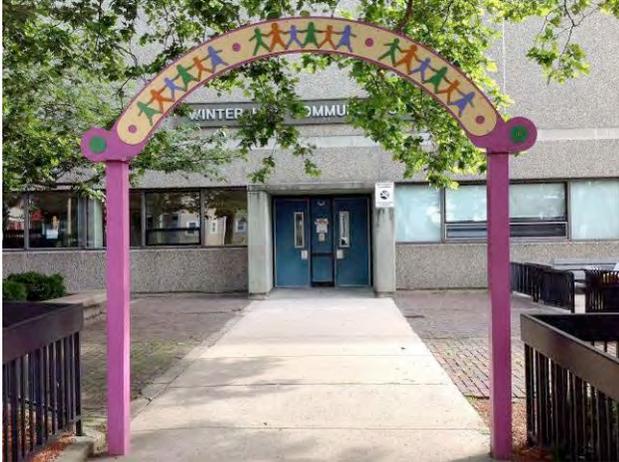
Photo 4

The building has a main entrance on Medford Street. A buzzer and intercom are placed at the entry door but accessible signage is not provided. (Photo 4)

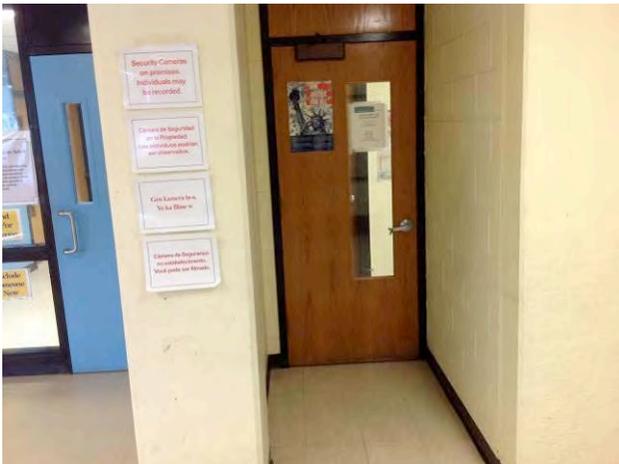
Photo 5

- many doors lack maneuvering clearance on the latch pull side; (Photo 5)
- certain spaces have doors that do not provide the minimum 32-inch clear width for accessible doors;
- dozens of single- and double-leaf doors exceed the maximum allowable force required to open them;
- some doors have non-compliant hardware. (Photo 6)

1. When doors do not have the minimum clear width for accessible doors, either keep them open during regular hours or replace them with wider doors.
2. Replace door knobs with lever hardware.
3. Create a comprehensive maintenance program and schedule to check and adjust the opening force of all exterior and interior doors. Where not possible, either keep heavy doors open during regular hours or add automatic openers.
4. Provide an automatic opener wherever doors do not have the required maneuvering clearance on their latch side. Prioritize entry doors and doors to toilet rooms.

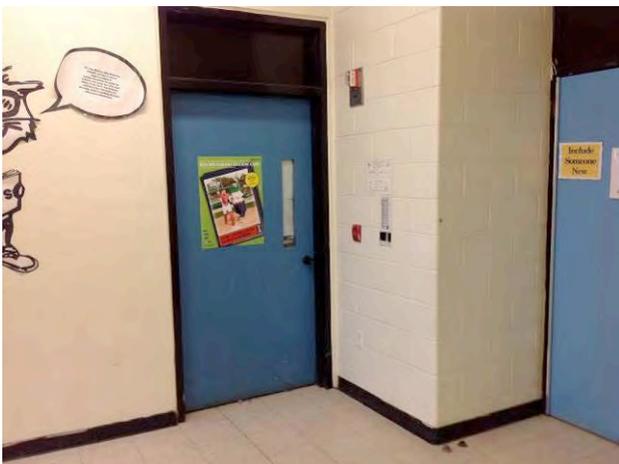
Photo 12

- Exterior accessible route signage is limited;
- Accessible entrances have worn or are missing ISA symbol;
- Not all permanent rooms and spaces are properly identified with ADA-compliant signs. (Photo 12)
- Toilet rooms are not identified accurately as Accessible or inaccessible restrooms lack signage directing to accessible restrooms;
- Inaccessible drinking fountains lack signage directing to accessible drinking fountains.

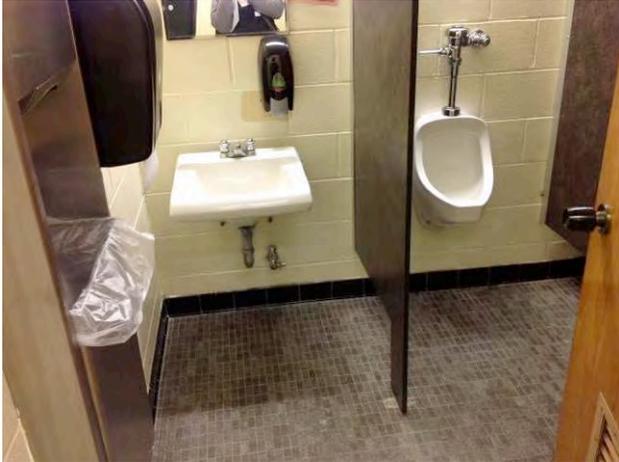
Photo 13

- Doors and doorways that are inaccessible because of dimensions, clear space, hardware, etc.; (Photo 13)
- Toilet is too far from sidewall;
- Toilet has wrap-around grab bars;
- One or more wall grab bars is incorrectly mounted or does not meet dimensional requirements; (Photo 14)
- Stall dispensers are mounted incorrectly;
- Latches are broken or require tight pinching, grasping or twisting;
- Coat hooks are missing or are mounted incorrectly;
- Lavatories lack sufficient knee clearance, wrapped pipes, and/or accessible faucets; (Photo 15)
- Soap and paper towel dispensers are mounted incorrectly or lack clear space in front of them;
- Mirrors are missing or are mounted incorrectly.

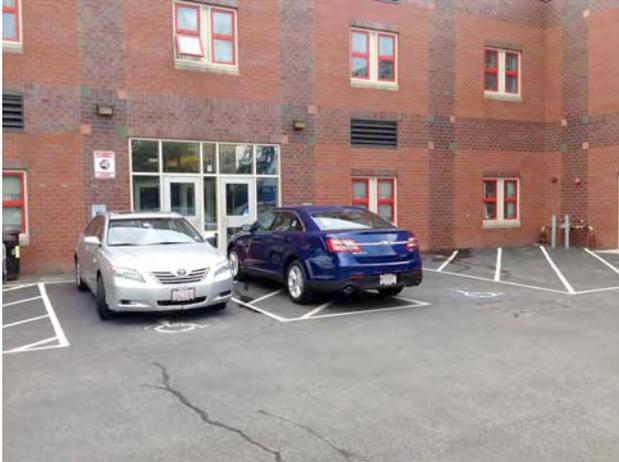
Photo 1

Off-street public parking is offered in the parking lot off Raymond Avenue. Two accessible parking spaces for public or staff were identified near the accessible entrance. Both signs do not meet the minimum allowable height. Additionally, one van designated parking spaced is not provided. (Photo 1)

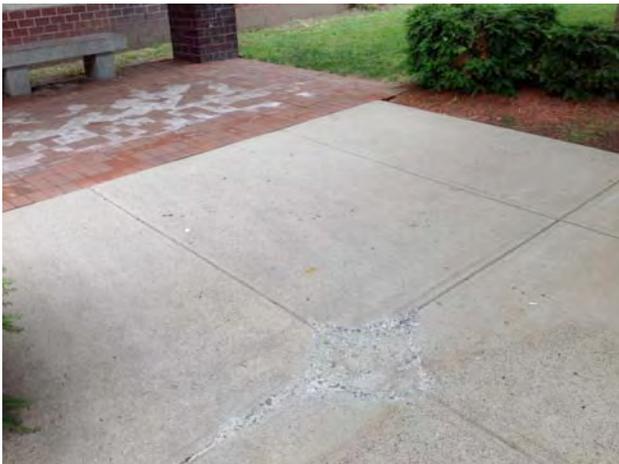
Photo 2

The entrances to the school are directly connected to the sidewalks along Powderhouse Boulevard and Raymond Avenue. Although the sidewalks and curb ramps are in good condition, a few deteriorated areas can be found near the entrance on Powderhouse Boulevard and near the exit facing the playground.

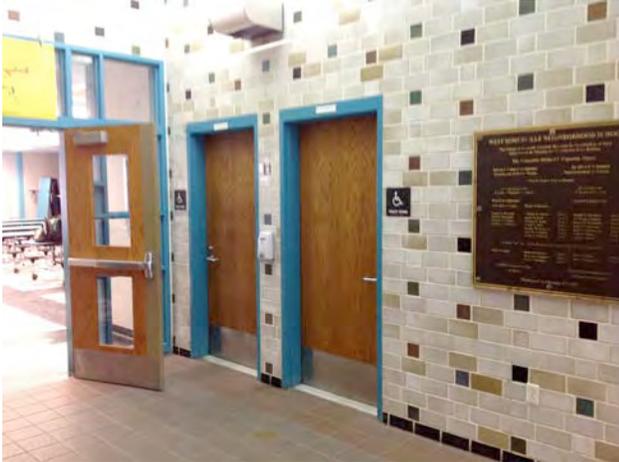
Photo 4

Throughout the building, several single- and double-leaf doors exceed the maximum allowable force required to open them. (Photo 4)
